SUMMARY

10508 Mississippi CR, Brooklyn Park, MN July 22, 2009

Report No. 1004, v.10

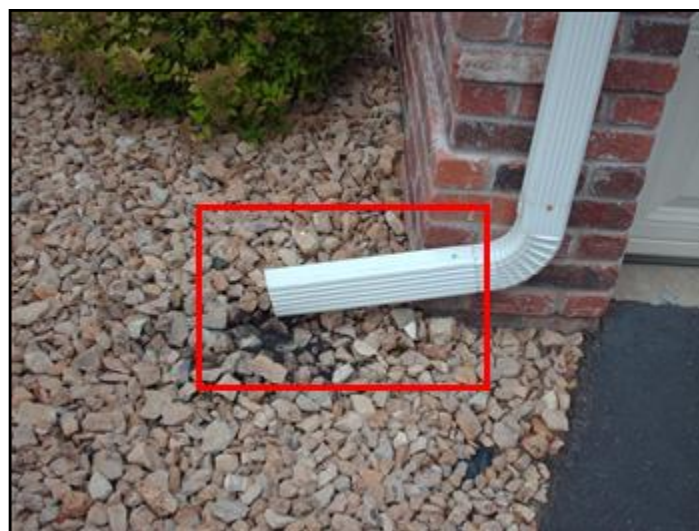
1.

Condition: • [Downspouts end too close to building](#)

Implication(s): Chance of water damage to contents, finishes and/or structure

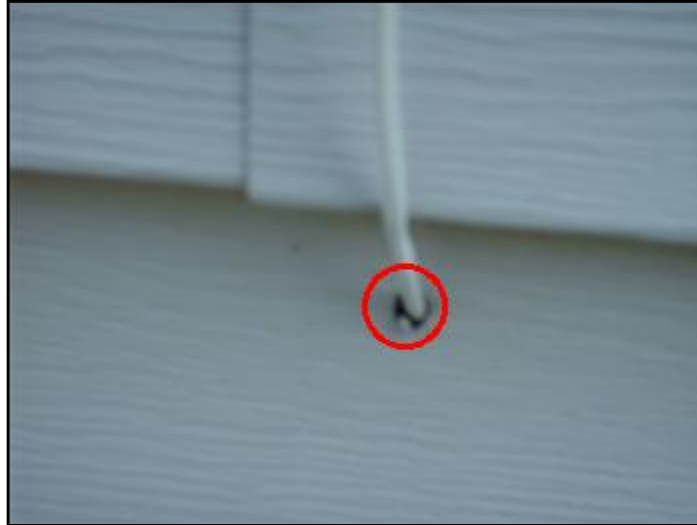
2.

Condition: • [Caulking missing or ineffective](#)

Implication(s): Chance of water damage to contents, finishes and/or structure

Location: North Exterior

Note: Appears to have missing caulk around electrical connections.

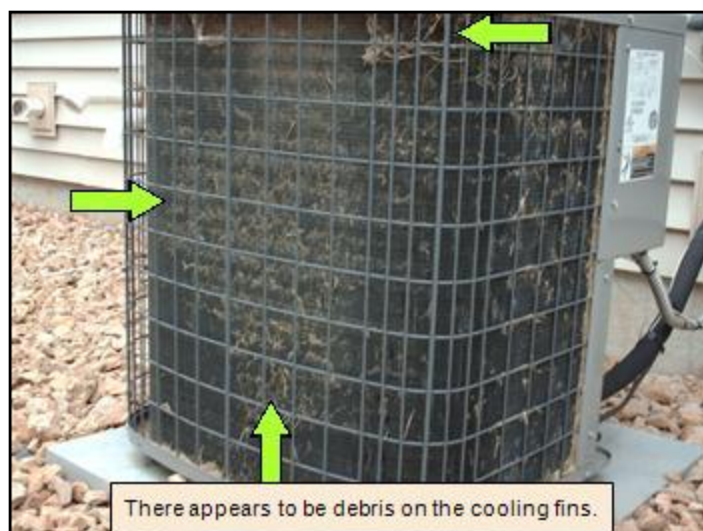
3.

Condition: • [Dirty](#)

Implication(s): Reduced system life expectancy | Increased cooling costs | Reduced comfort

Location: North Exterior

Note: Regular cleaning can maximize the performance and extend the useful life of the A/C.

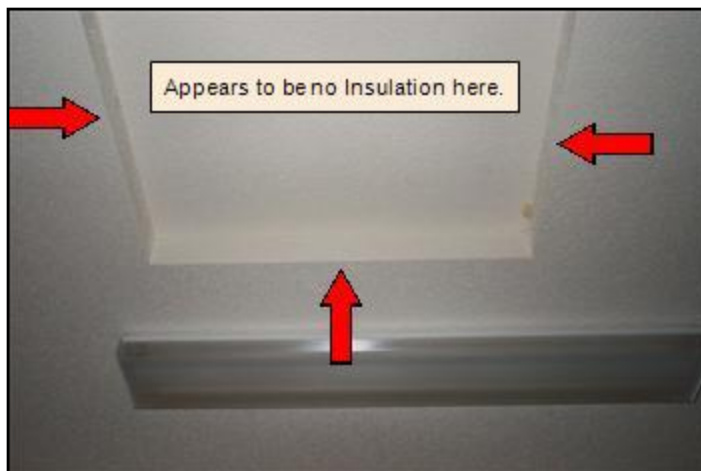
4.

Condition: • [Gaps or voids](#)

Implication(s): Increased heating and cooling costs | Reduced comfort

Location: Attic Panel

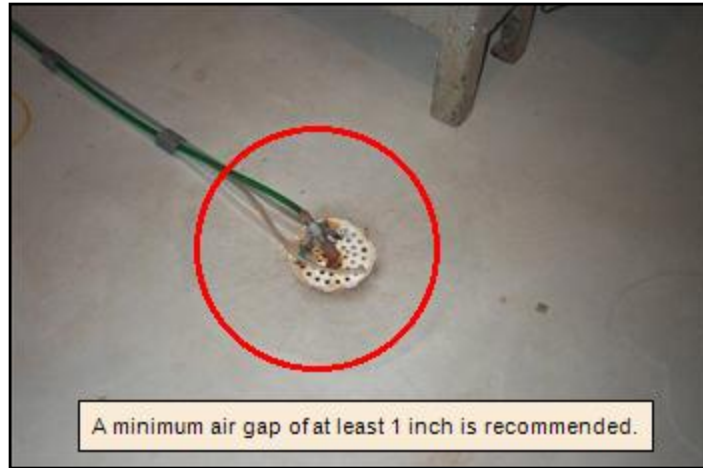
5.

Condition: • [Cross connections](#)

Implication(s): Contaminated drinking water

Location: Basement Utility Room

Note: utility room floor drain

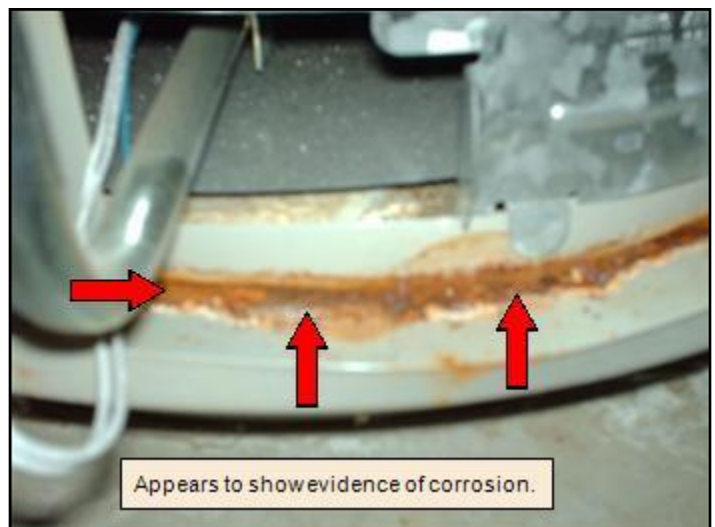
7.

Condition: • [Poor connections](#)

Implication(s): Equipment not operating properly | Hazardous combustion products entering home

Note: The condensate line appears to be disconnected resulting in some corrosion on water heater tank.

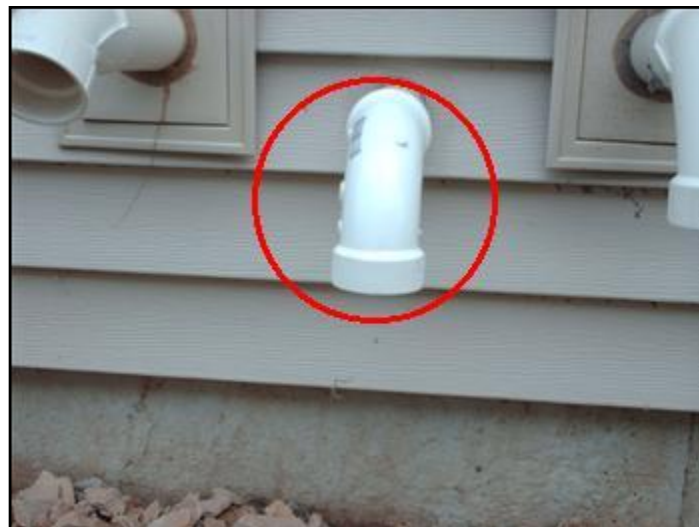
8.

Condition: • [Discharge pipe problems](#)

Implication(s): Chance of water damage to contents, finishes and/or structure

Location: North Exterior

Note: The discharge is recommended a minimum of 6 feet away from the home.

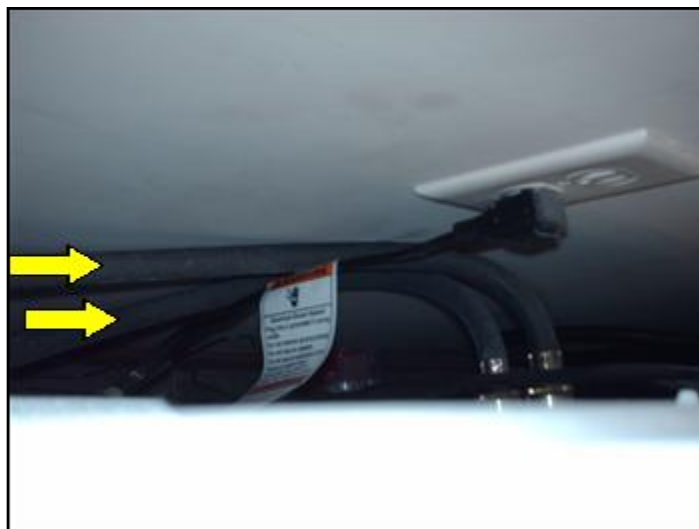
9.

Condition: • Water piping damaged

Implication(s): Chance of water damage to contents, finishes and/or structure

Location: First Floor Laundry Area

Note: Recommend burst proof connecting hoses to the washing machine. The current hose has a high probability of failure.

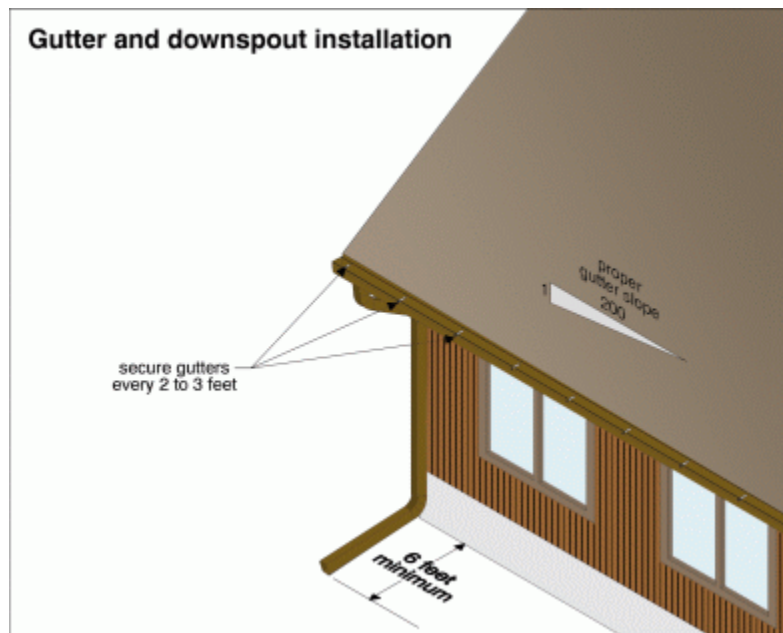
Condition: • [Missing](#)

Implication(s): Chance of water damage to contents, finishes and/or structure

Note: recommend gutters to be installed through to reduce the likelihood of moisture intrusion.

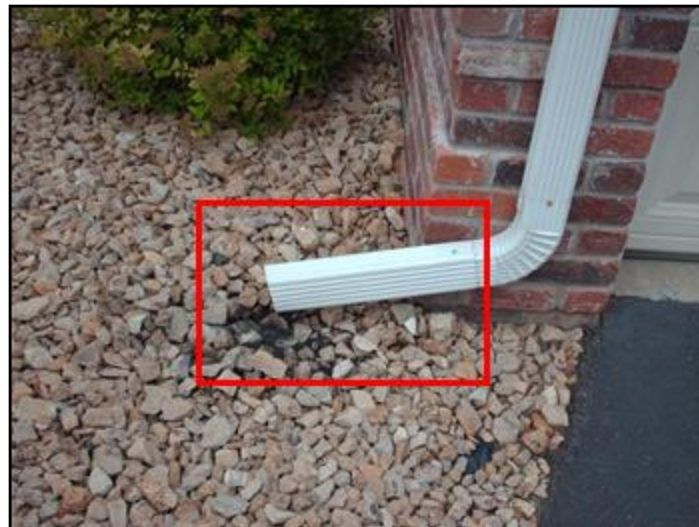
10.

Condition: • [Downspouts end too close to building](#)

Implication(s): Chance of water damage to contents, finishes and/or structure

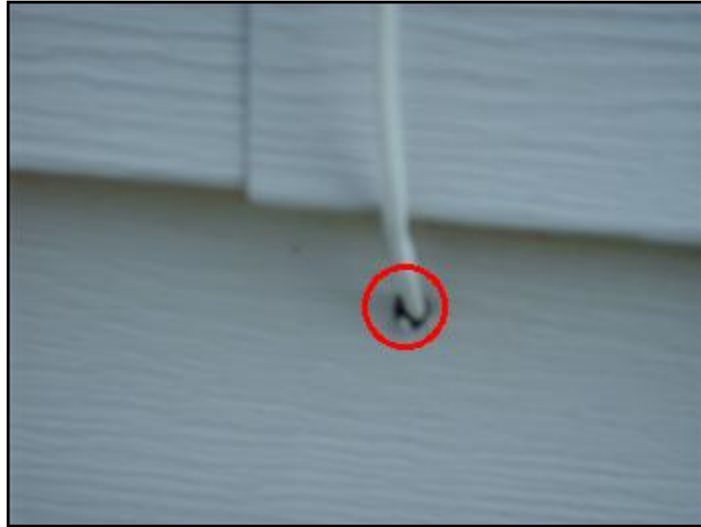
11.

Condition: • [Caulking missing or ineffective](#)

Implication(s): Chance of water damage to contents, finishes and/or structure

Location: North Exterior

Note: Appears to have missing caulk around electrical connections.

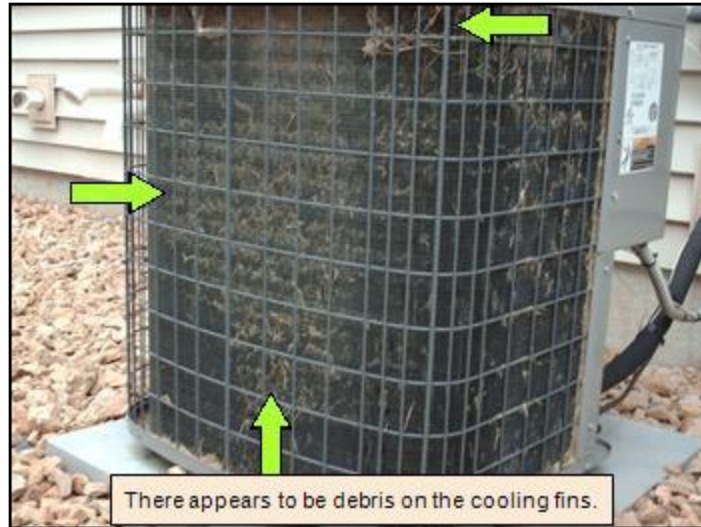
14.

Condition: • [Dirty](#)

Implication(s): Reduced system life expectancy | Increased cooling costs | Reduced comfort

Location: North Exterior

Note: Regular cleaning can maximize the performance and extend the useful life of the A/C.

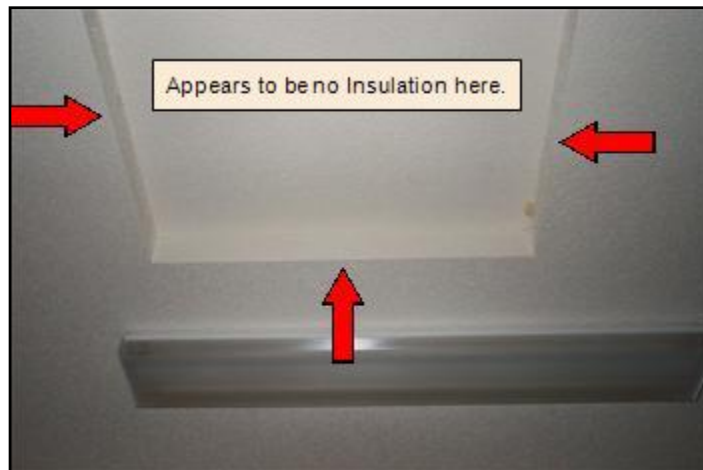
15.

Condition: • [Gaps or voids](#)

Implication(s): Increased heating and cooling costs | Reduced comfort

Location: Attic Panel

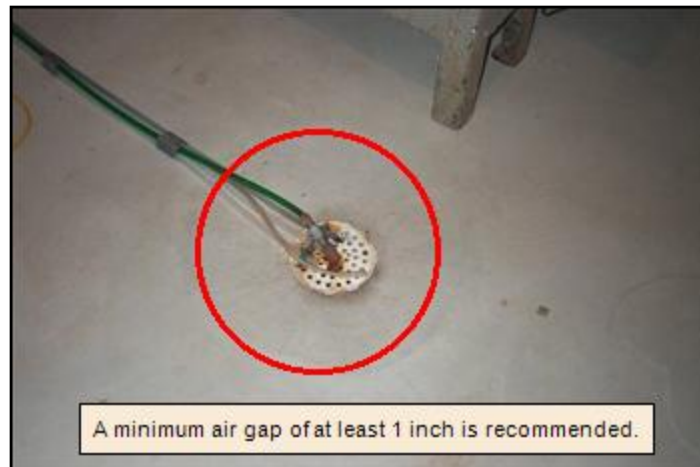
16.

Supply plumbing \ Supply piping in house
Condition: • [Cross connections](#)
Implication(s): Contaminated drinking water
Location: Basement Utility Room
Task: Correct
Note: utility room floor drain

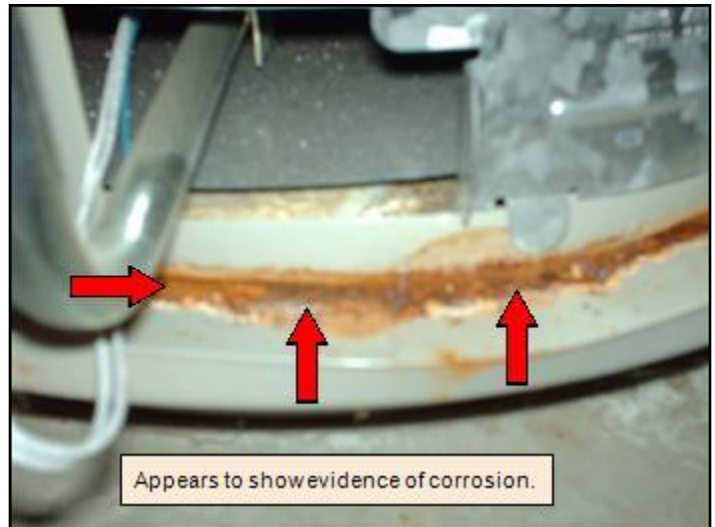
18.

Condition: • [Poor connections](#)

Implication(s): Equipment not operating properly | Hazardous combustion products entering home

Note: The condensate line appears to be disconnected resulting in some corrosion on water heater tank.

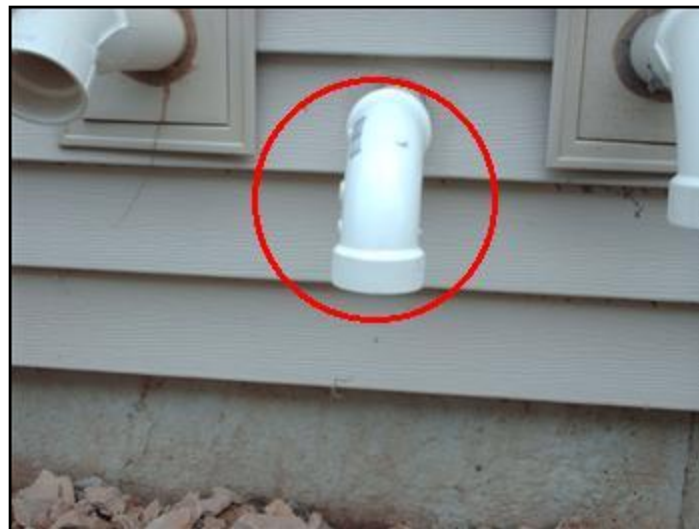
19.

Condition: • [Discharge pipe problems](#)

Implication(s): Chance of water damage to contents, finishes and/or structure

Location: North Exterior

Note: The discharge is recommended a minimum of 6 feet away from the home.

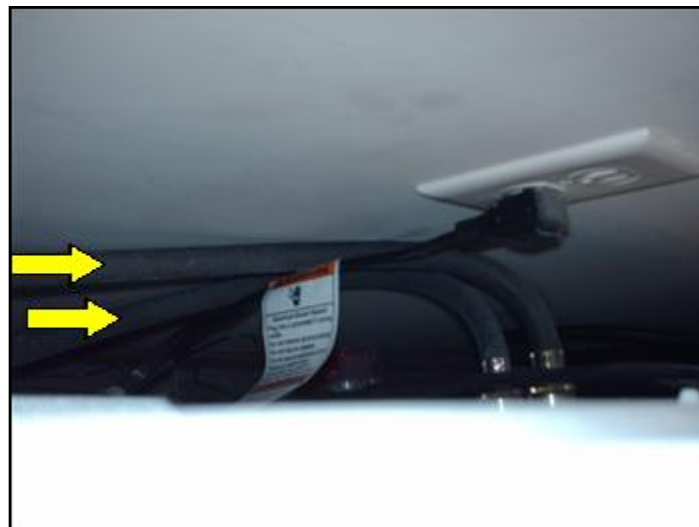
20.

Condition: • Water piping damaged

Implication(s): Chance of water damage to contents, finishes and/or structure

Location: First Floor Laundry Area

Note: Recommend burst proof connecting hoses to the washing machine. The current hose has a high probability of failure.
