SUMMARY

10508 Mississippi CR, Brooklyn Park, MN July 22, 2009

Report No. 1004, v.10

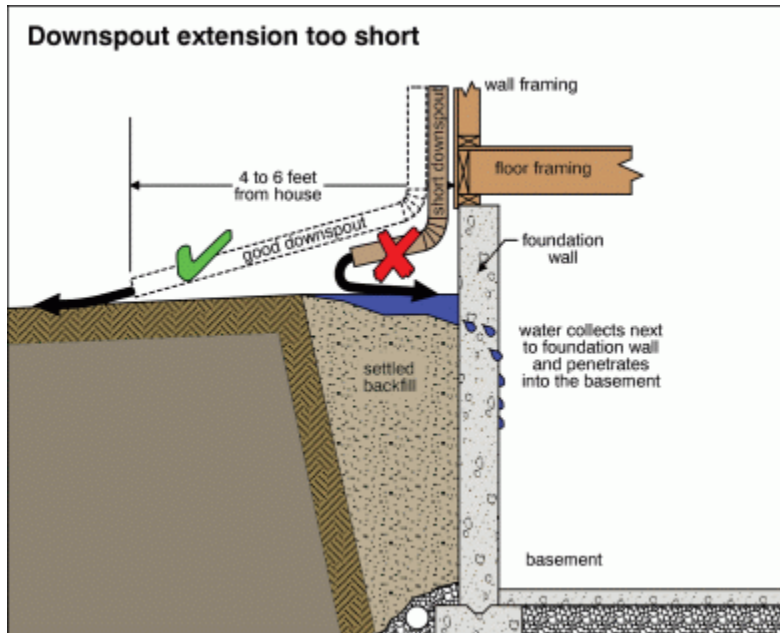
Roof drainage \ Downspouts

Condition: • [Downspouts end too close to building](#)

Implication(s): Chance of water damage to contents, finishes and/or structure

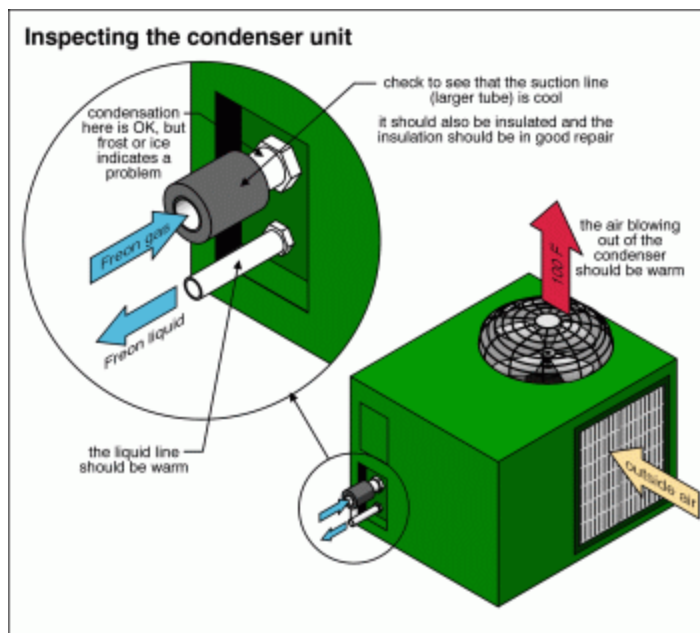
Air conditioning \ Air cooled condenser coil

Condition: • [Dirty](#)

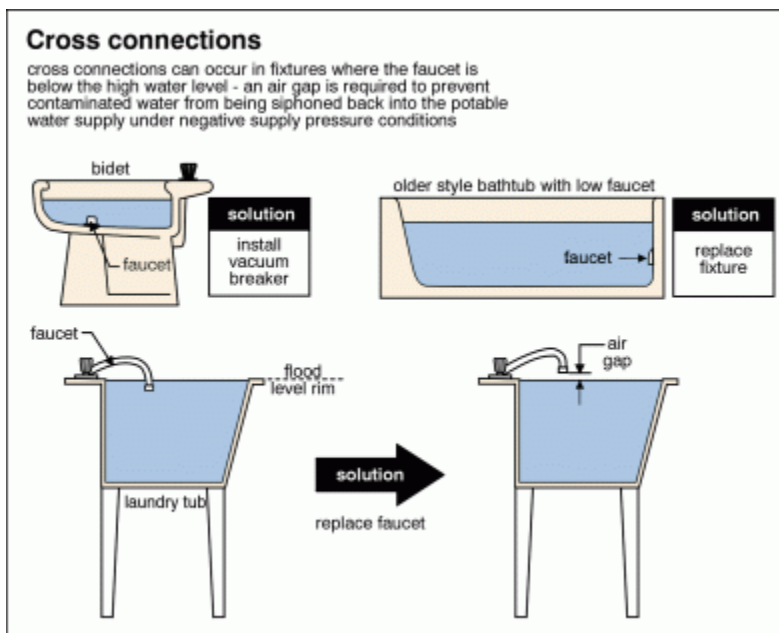
Condition: • [Cross connections](#)

Note: utility room floor drain

Task: Correct

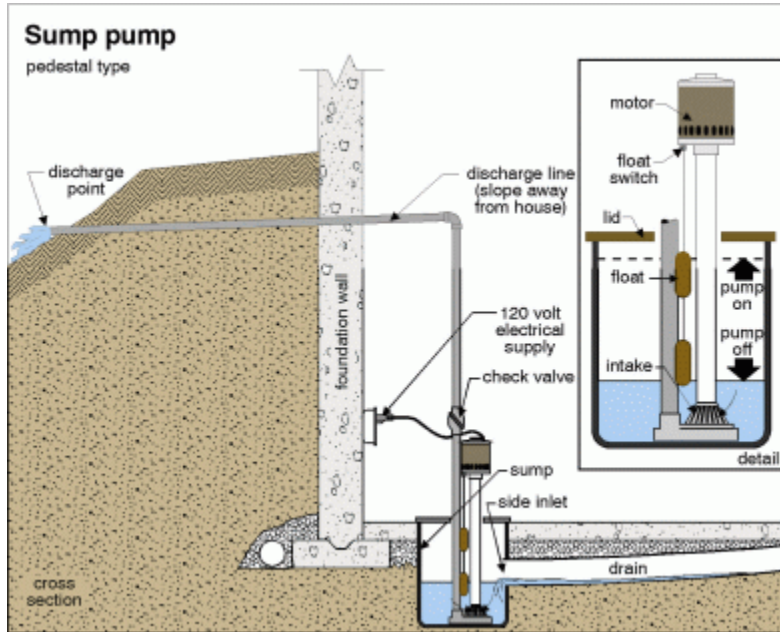
Condition: • [Discharge pipe problems](#)

Implication(s): Chance of water damage to contents, finishes and/or structure

Note: The discharge is recommended a minimum of 6 feet away from the home.

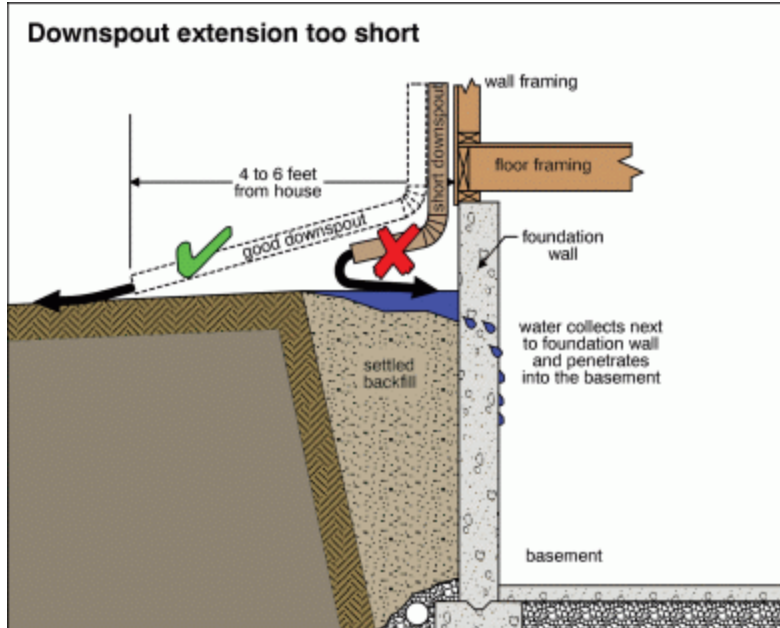
Condition: • [Downspouts end too close to building](#)

Implication(s): Chance of water damage to contents, finishes and/or structure

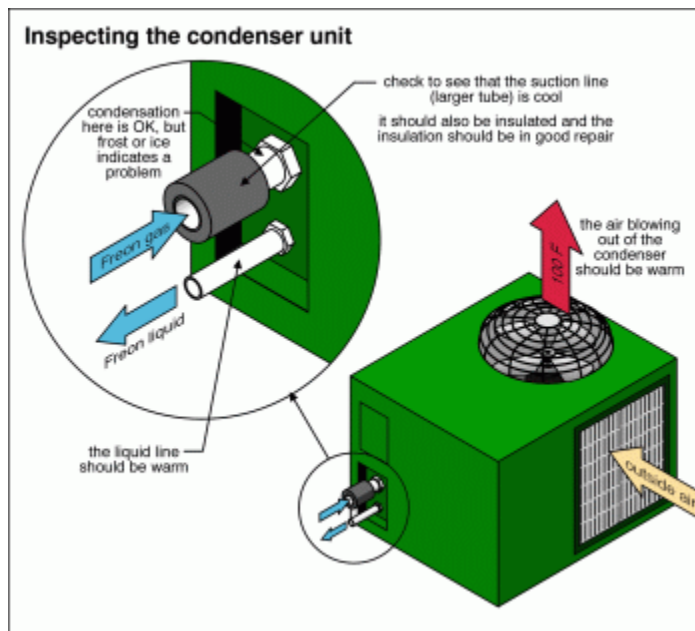
Air conditioning \ Air cooled condenser coil

Condition: • [Dirty](#)

Note: Regular cleaning can maximize the performance and extend the useful life of the A/C.

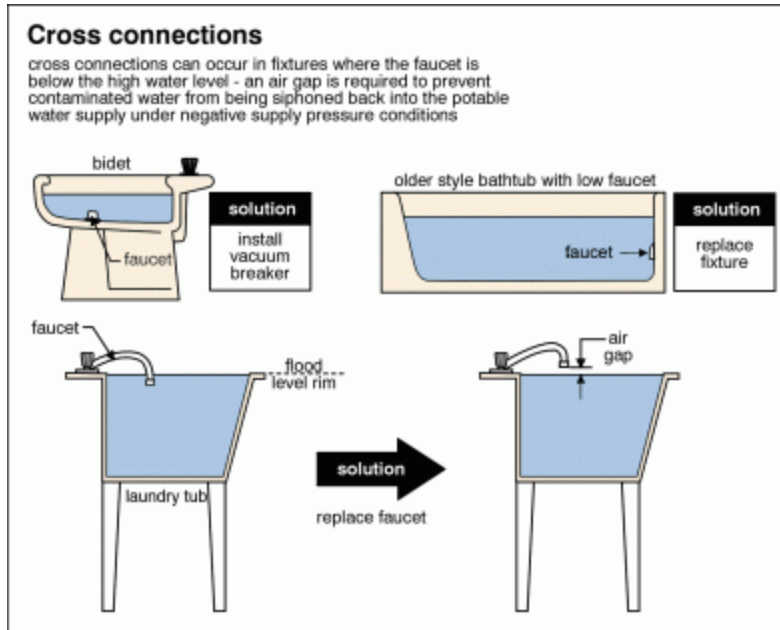
Supply plumbing \ Supply piping in house
Condition: • [Cross connections](#)
Implication(s): Contaminated drinking water
Location: Basement Utility Room
Task: Correct
Note: utility room floor drain

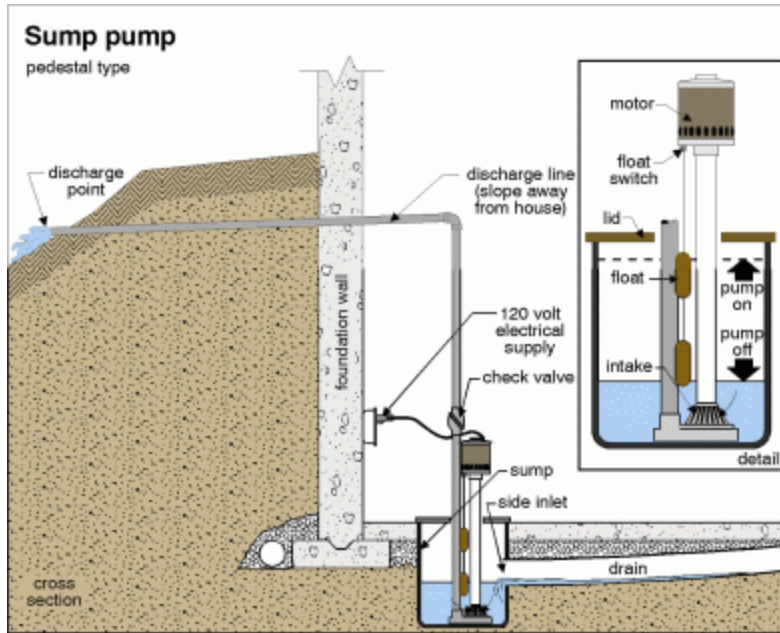
Condition: • [Discharge pipe problems](#)

Implication(s): Chance of water damage to contents, finishes and/or structure

Note: The discharge is recommended a minimum of 6 feet away from the home.

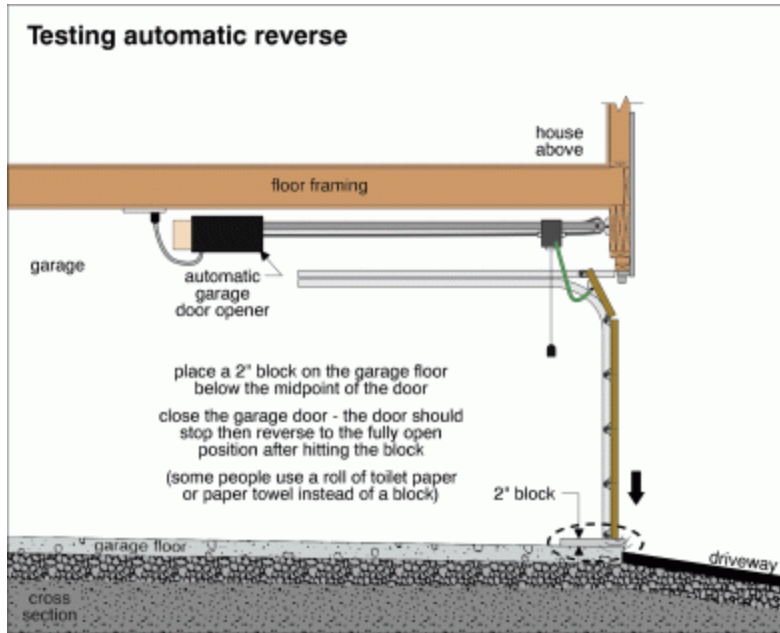
Condition: • [Fails to auto reverse](#)

Location: Garage
